febiEXAKT

Belt tensioner

febi no. 26775

for
Mercedes Benz CDi engines

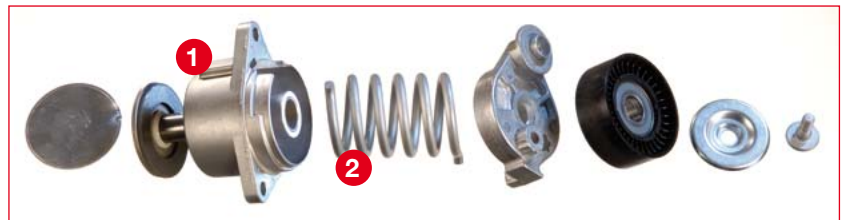
ref. no. 611 200 04 70

The noise is generated because the spring is too long and makes direct contact with the base of the housing (1). Only the spring's torsional characteristics are important for this application (2), (6).

The noise is caused when the spring touches the cast-in hollow pin (3) and the base of the housing (4).
