febiEXAKT

Wheel bearing kit including wheel bearing and axle nut

febi no. 24414

Audi A2
Seat Cordoba, Ibiza IV
Škoda Fabia
VW Polo, Fox

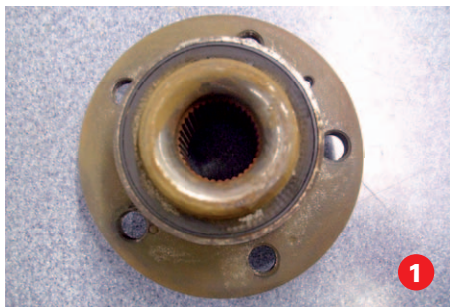
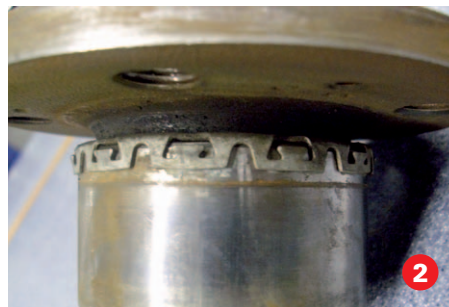
The wheel bearing makes a lot of noise when driving.

Water is getting into the wheel bearing due to a damaged sealing washer and rust is forming, see photos (1) and (2). The sealing washer (3) located between the CV joint and the wheel hub is made of plastic and is easily damaged during removal or due to external factors. When the sealing washer is damaged, it no longer makes proper contact. Water can get inside the wheel bearing more easily once the sealing washer is damaged or dirty. The consequences are premature failure of the bearing and a lot of noise.

Look out for damage to the sealing washer! As a general rule, febi recommends replacing the sealing washer when fitting a wheel bearing. Important: The sealing washer comes in two sizes (64 mm and 72 mm). Pay particular attention to the size (in inches) of the wheels!
