Belt tensioner

for Mercedes Benz CDi engines
ref. no. 611 200 04 70

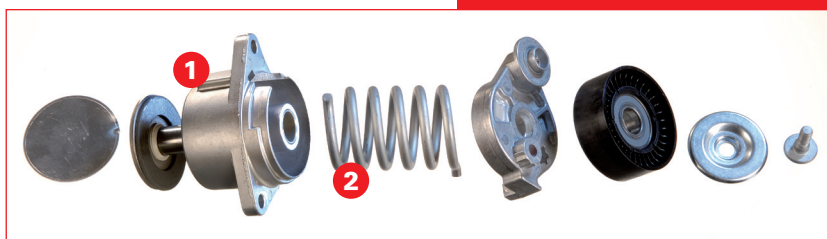
ref. no. 611 200 04 70

For design reasons, when the vehicle is driven with the original version of the belt tensioner installed (ref. no. 611 200 04 70), noise may occur. (The manufacturer has now replaced this version.)

The noise is generated because the spring is too long and makes direct contact with the base of the housing (1). Only the spring's torsional characteristics are important for this application (2), (6).

The noise is caused when the spring touches the cast-in hollow pin (3) and the base of the housing (4).
