Technical Bulletin

Timing belt/kit installation on GM (Isuzu) 1.7D engines

GATES REFERENCE:	5563XS/K015563XS/K025563XS/K035563XS
MAKE:	CHEVROLET, OPEL, VAUXHALL
MODEL:	Astra, Combo, Corsa, Meriva, Tour, Zafira
ENGINE:	Isuzu 1.7 DTI
ENGINE CODE:	A17DT, A17DTR, Y17DT, Y17DTH, Y17DTL, Z17DT, Z17DTH, Z17DTR

This replaces Technical Bulletin N° 009.

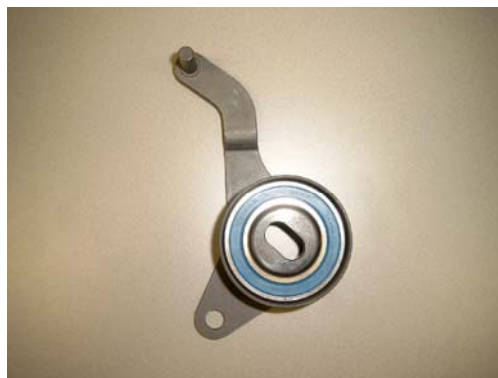
Fig. 1 OE ref. 5636724

Up to engine nr 328703 (last 6 digits) the initial tensioner (Fig. 1) was installed. From engine nr 328704 this tensioner was replaced on OE level by the new version (Fig. 2) for this 1.7 D engine.

That is why our kits only contain the new tensioner.

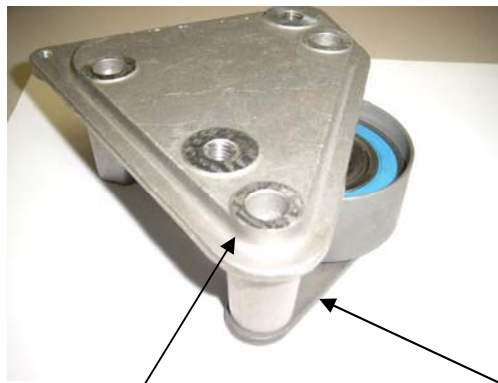
Fig. 3

As the initial tensioner base plate was sitting under one of the legs of the engine support bracket (Fig. 3), K015563XS can only be used from engine nr 328704 on.

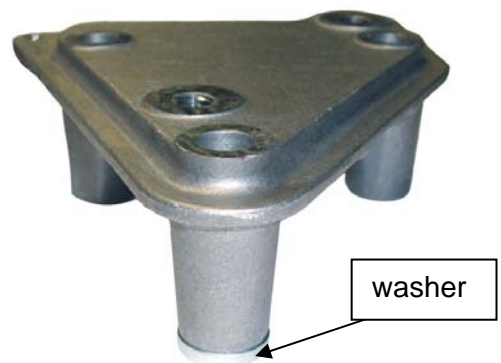
Fig. 4

K025563XS is supplied with a washer to compensate for the shorter leg of the early engine support bracket (Fig. 4), and a stud which is needed to hook the new tensioner spring on (Fig. 5). This K02 can always be used: up to engine nr 328703, using the washer and the stud; and from engine nr 328704 without the washer and the stud.

- 11) Stick the washer (Fig. 4) on the bottom engine support leg (using fixing glue) in order to avoid losing the washer when loosening the support bracket bolt later.

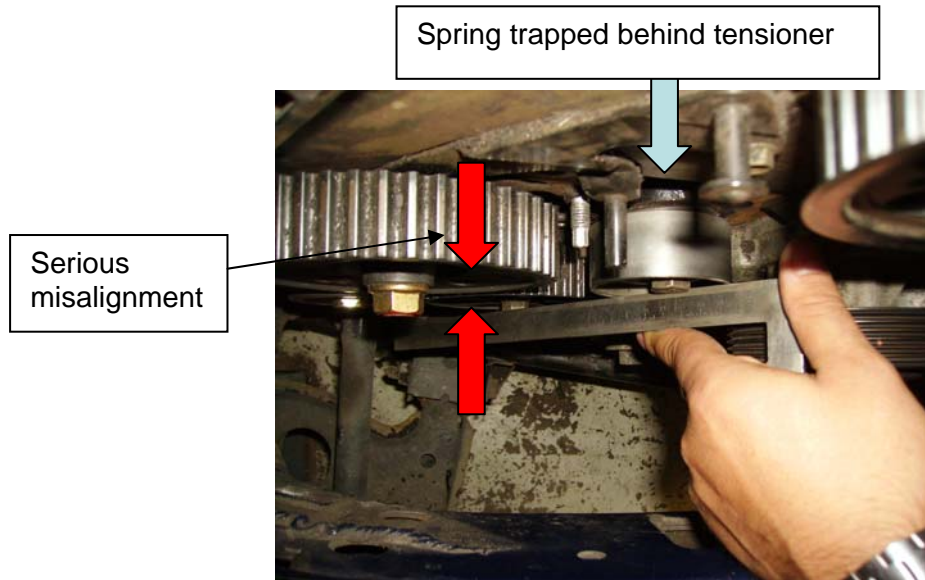
Fig. 6

- 4) Install new coil spring tensioner (spring over stud, bolt hand tight); make sure tensioner is sitting perfectly against engine block. If not, the spring could end up between the tensioner and the engine block, creating a serious tensioner misalignment (see Fig. 6)

- 1) Remove old tensioner, spring, idler and belt
- 2) Install new idler and bolt
- 3) Install new coil spring tensioner (spring over stud, bolt hand tight); make sure tensioner is sitting perfectly against engine block. If not, the spring could end up between the tensioner and the engine block, creating a serious tensioner misalignment (see Fig. 6)

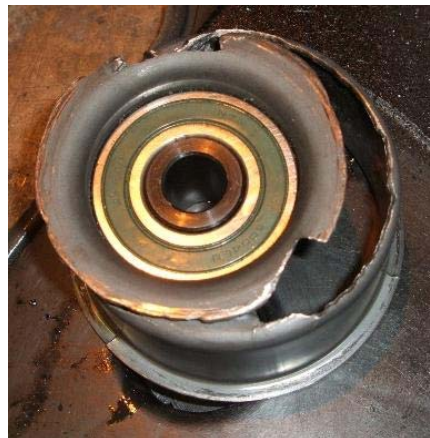
Fig. 8

This engine is VERY sensitive to wrong tension. Because of this, the installation/tensioning procedure must be followed strictly and precisely. Failure to do so will most certainly result in an idler failure.

Failure to observe this procedure could result in the belt tension being too high leading to an overload of the guide pulley, between the oil pump and injection pump, usually causing the idler pulley to collapse (Fig. 8) and leading to severe engine damage.
