033

30/12/2009

Technical Bulletin

Renault 1.4/1.6 16V Petrol Engines

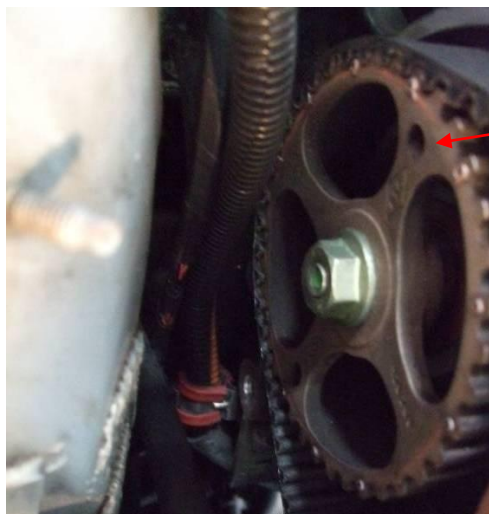
Fig. 1

Excessive play on the water pump bearing often occurs, causing the belt to track forward and force the camshaft pulley flanges to detach and enter the drive system, ultimately causing belt failure.

Also previous mechanical damage to the flanges can lead to this result (Fig.1).

The camshaft pulley design has changed on later engines (but OE ref. remained the same), preventing this failure mode.

Flange detached

We would recommend that the water pump is inspected and if necessary replaced using the water pump kit KP15501XS if applicable.

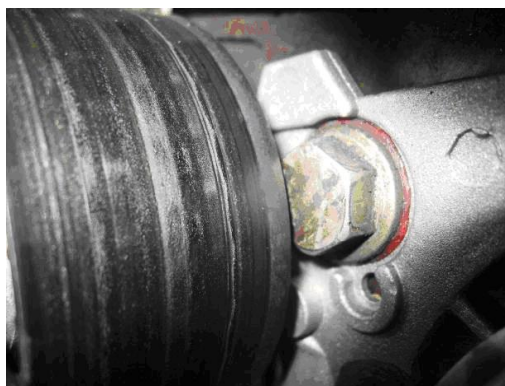
When changing the water pump, make sure the correct bolts/washers are used and torqued up to the correct value. Fig. 2 shows that the space between the water pump bolt and the tensioner pulley is quite small.

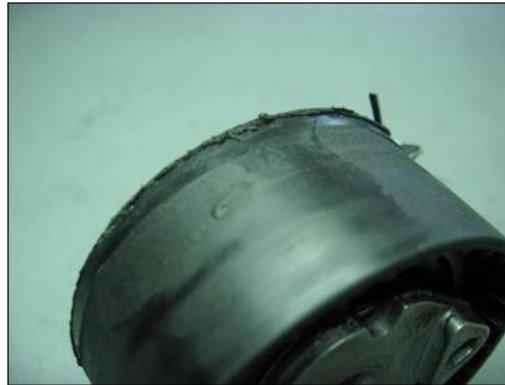
Fig. 3

Incorrect parts, or bolts coming undone, can lead to contact with the tensioner pulley (Fig. 3)

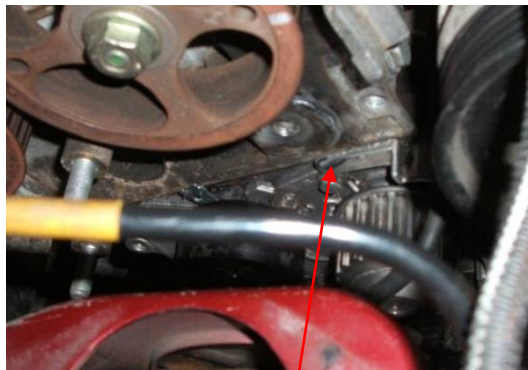
Fig. 4

When replacing the idler pulley, ensure the spacer (sitting between the old pulley and the engine block) is fitted between the new pulley and the engine block. If not, then the idler pulley will touch the water pump, causing idler/belt failure (Fig. 4 and 5).

Rubbing mark

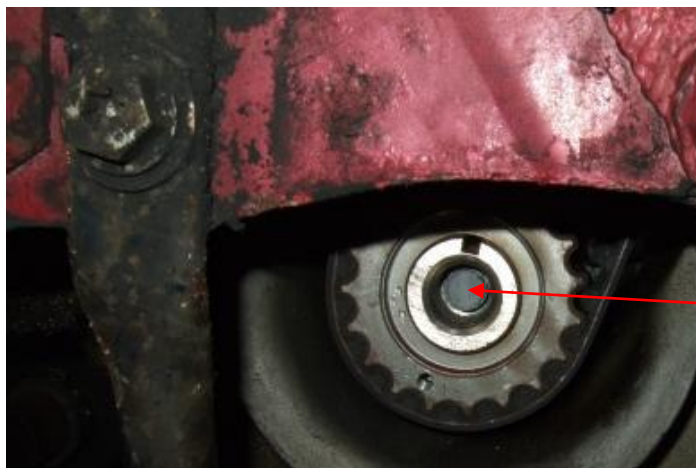
Fig. 6

Failure to apply the correct torque could lead to bolt shear. (Fig. 6)

Bolt sheared

The crankshaft bolt (OE ref. 8200557644 and supplied in the kits) is a stretch bolt and should be replaced. The correct torque setting of this bolt is very important. The torque varies with the engine code and model, so please refer to the car manufacturers data for your vehicle.

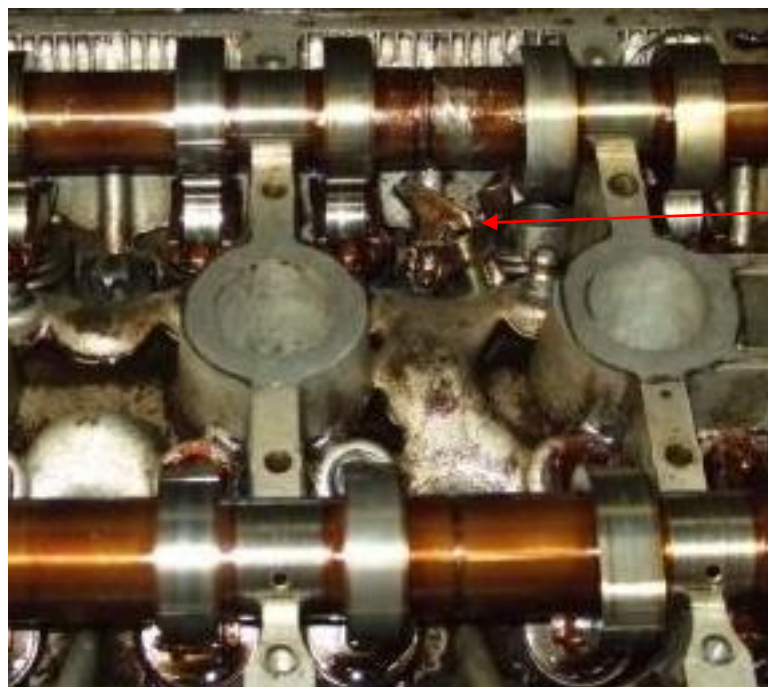
Fig. 7

In the event of an engine repair after piston to valve contact, close inspection of the camshaft rockers is essential. It is possible that the rocker could have sustained damage. In this case the rocker must be replaced. If not done so the rocker will fail causing the camshaft to seize. (Fig. 7)

Rocker broken
