## DriveAlign® Tensioner T38192

**T38192/K046PK1660**

AUDI, SEAT, SKODA, VOLKSWAGEN  
A3, Cordoba, Leon, Toledo, Octavia, Bora,  
Caddy, Golf, New Beetle, Polo

1.9 Tdi 8V

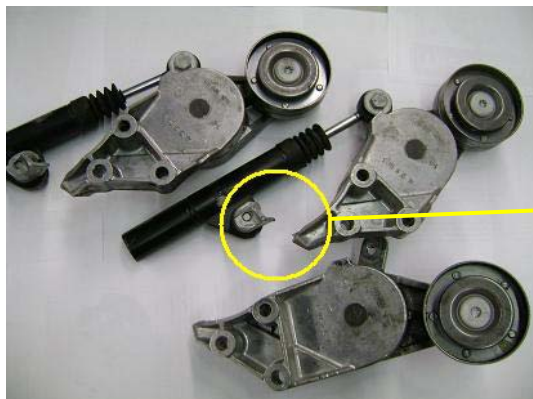
Fig 1

Different failures of this tensioner have led to garage visits where the reason of the early failures of this tensioner were investigated. During the examinations, the malfunction of the OAP was proven. The OAP not working properly anymore leads to abnormal belt vibrations, causing the tensioner bracket to be affected by material fatigue; leading to rupture (Fig. 1 and 2).

The bracket will always shear at the same point (just above the connection of the bracket with the hydraulic damper).

The broken tensioner bracket is the result of excessive vibrations, not the cause!

In all these cases, as the OAP did not work anymore, the hydraulic tensioner element had to cope with abnormal vibrations in the drive; leading to bracket material fatigue.

Replace the alternator pulley with the prescribed Gates part.  
Follow OE recommended installation procedure.

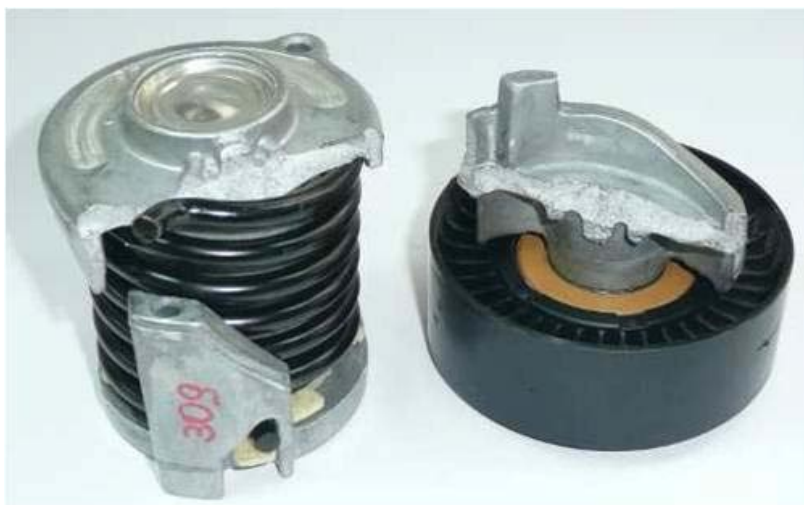
Fig. 3

Also in other cases worn/blocked OAP's have led to the failure of the tensioner (Fig. 3).
