# 042

# Technical Bulletin

## VAG 2.5 V6 TDI – Timing Belt set-up.

2.5 V6 TDI

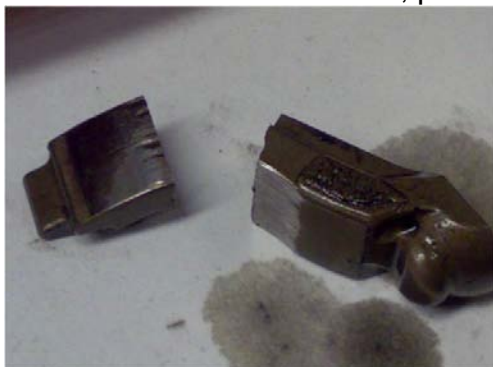
Fig. 1

- 1) Camshaft wear on the early models (up to 2003): there are potential issues with insufficient lubrication of the camshafts. This will lead to power loss, insufficient combustion (exhaust smokes), possible shearing off of the (normal) rocker arms (Fig. 1); resulting in camshaft wear (Fig. 2), blockage and belt rupture. Later models equipped with “roller” rocking arms do not have this issue anymore.
- 2) Although the Timing Belt is tensioned by means of a hydraulic tensioner element, many errors are made during the tensioner setting, leading to premature belt failure.
- 3) In some cases a rough running vacuum pump (hard points) will put extra wear on the belt, possibly leading to premature failure.

It is vital that the correct installation tools (to be found in GAT4450) are used in order to fit the belts correctly. To prevent premature belt failure, always follow the manufacturers’ recommended fitting procedure.

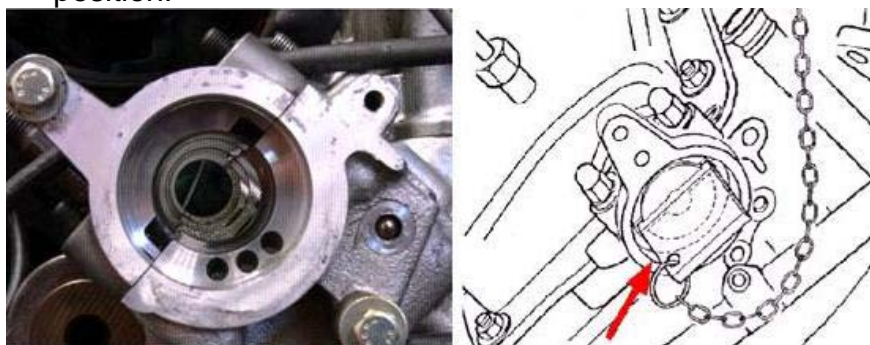
Fig. 5

**NOTE:** Setting plates **cannot** be used to hold camshafts in place when releasing sprocket bolts. They are only for holding timing position!

- 2) Remove the TDC cap from the engine block and put in the crankshaft locking pin (GAT4401); which is used to retain the crankshaft at TDC position. The locking pin has to be screwed in via a threaded hole in the crankcase (Fig.4).
- 3) By removing both camshaft cover (cap) and the vacuum pump at the back of the cylinder heads, you will be able to put the camshaft setting plates (GAT4451) in the slots in the rear of each camshaft (Fig. 5). They are supplied with chains which are attached to a suitable engine part to prevent them from falling.

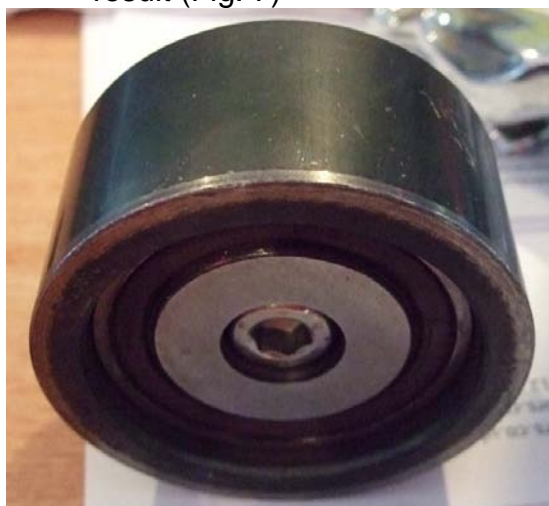
Fig. 6

- 11) Install new idler. **ATTENTION!!!** The idler now has a countersunk hole (Fig 6), needing a shorter bolt (supplied in the kit). Failure to use the correct bolt will lead to incorrect clamping, with a sheared bolt as a result (Fig. 7)

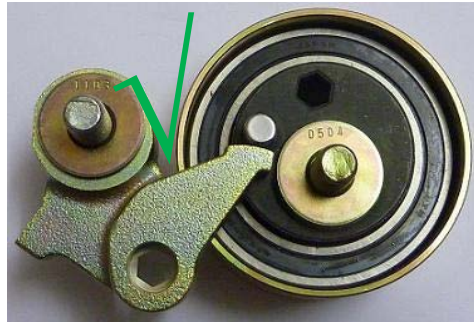
Fig. 8

Fig 8 shows the only possible **correct** lever/pin contact.

Correct

Particular attention needs to be taken in relation to the position of the lever and pin located behind the tensioner roller:

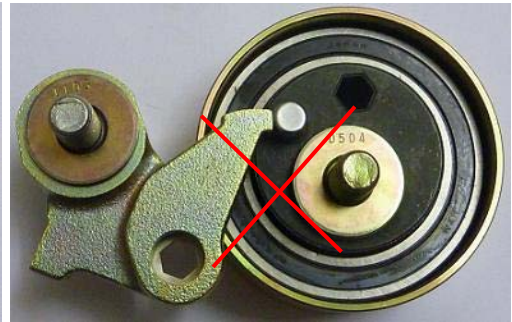
Fig. 9

Incorrect

Any incorrect contact of the lever arm with the pin on the tensioner, or lack of washer, will cause serious damage to the system; with belt failure as a result (Fig.10).

Do not forget (1) washer behind lever and tensioner pulley!!
