# 045

23/12/2011

# Technical Bulletin

## Tensioner/kit installation on PSA diesel engines

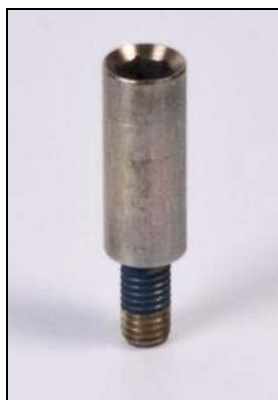
Fig. 1

We've found several cases where the tensioner pulley was not positioned correctly over the mounting stud (Fig. 1).

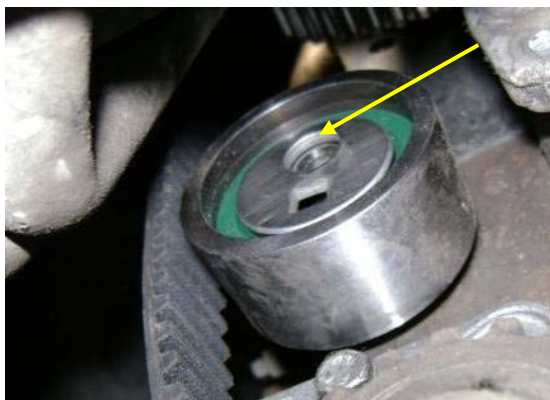
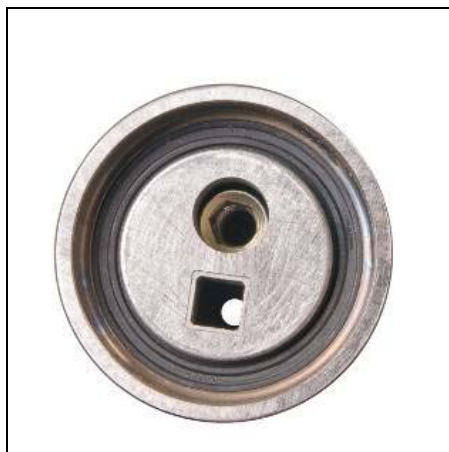
Fig. 2

An incorrect tensioner installation will usually lead to an incorrect tension, but in this case the result will often be misalignment. This misalignment will cause the belt to track, leading to engine failure.

If the inside of the tensioner front plate rests against the front edge of the mounting stud (Fig. 2 and 3), the result will be that the tensioner pulley is not sitting straight over the stud **EVEN** after the fixing bolt (Fig. 4) has been correctly torqued. This will lead to a belt misalignment, resulting in premature failure.

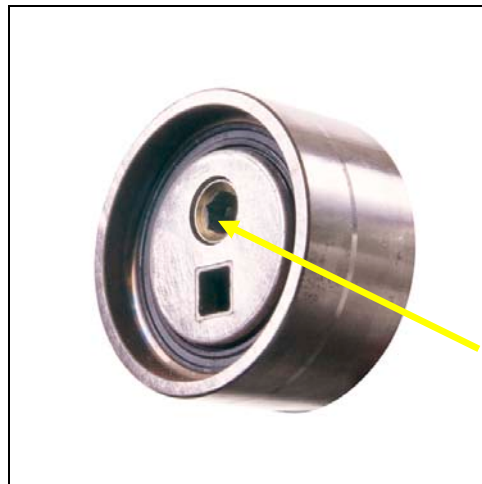
Fig. 5 shows a correct stud position.

**Important:** Engine must be cold.

We advise to replace the water pump together with the belt.
