A complete solution for Ford Mondeo 1+2!

Stabilizer mounting repair kit (with clamps) febi 27400

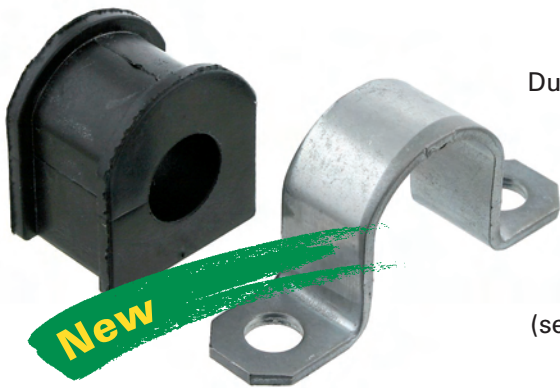
Due to a change of design of the anti roll bar mounting by the car manufacturer, problems occurred when fitting the stabilizer mounting (febi 27355). The former semi-circular design has now been changed to a flat design identical to the original part (see picture 3).

This means the mounting clamp must also be changed. The stabilizer mounts and clamps should always be replaced in pairs to ensure a professional level of servicing.

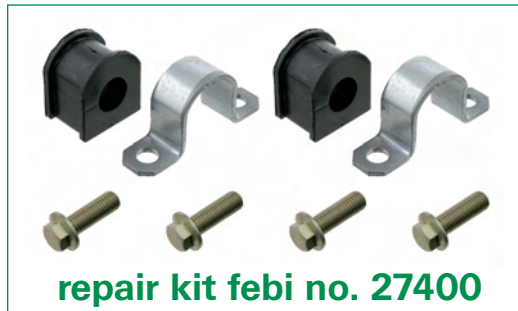
repair kit febi no. 27400

This repair kit contains stabilizer mounts with matching mounting clamps as well as the required high tensile mounting screws (10.9 grade).
