febiEXAKT

Belt tensioner

febi no. 26775

for
Mercedes Benz CDi engines

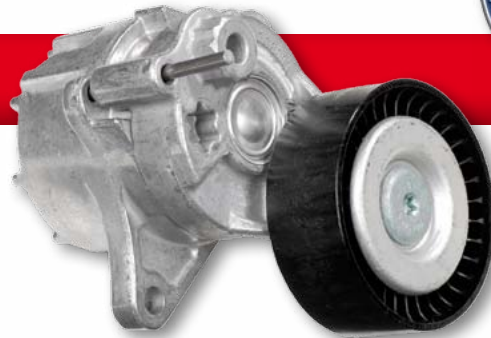
For design reasons, when the vehicle is driven with the original version of the belt tensioner installed (ref. no. 611 200 04 70), noise may occur. (The manufacturer has now replaced this version.)

The noise is generated because the spring is too long and makes direct contact with the base of the housing (1). Only the spring's torsional characteristics are important for this application (2), (6).

The noise is caused when the spring touches the cast-in hollow pin (3) and the base of the housing (4).

febi supplies the belt tensioner febi no. 26775 (ref. no. 646 200 02 70) for the free aftermarket. A highly wear-resistant plastic bushing (5) distance the spring from the base of the housing and prevents metal-to-metal contact where the spring is located. Since only the springs's torsional characteristics are important the height has been reduced (6). The spring makes contact with the plastic bushing (7) and is therefore prevented from touching the base of the housing. No noise can therefore occur. In the new version (8), a steel pin has been cast in the base of the housing in order to center the spring.
