febiEXAKT

Wheel bearing kit including wheel bearing and axle nut

febi no. 24414

Audi A2
Seat Cordoba, Ibiza IV
Škoda Fabia
VW Polo, Fox

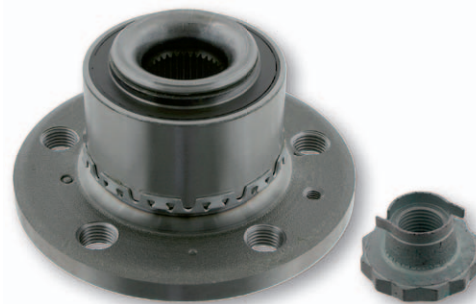
The wheel bearing makes a lot of noise when driving.

Water is getting into the wheel bearing due to a damaged sealing washer and rust is forming, see photos (1) and (2). The sealing washer (3) located between the CV joint and the wheel hub is made of plastic and is easily damaged during removal or due to external factors. When the sealing washer is damaged, it no longer makes proper contact. Water can get inside the wheel bearing more easily once the sealing washer is damaged or dirty. The consequences are premature failure of the bearing and a lot of noise.

Look out for damage to the sealing washer! As a general rule, febi recommends replacing the sealing washer when fitting a wheel bearing. Important: The sealing washer comes in two sizes (64 mm and 72 mm). Pay particular attention to the size (in inches) of the wheels!
