febiEXAKT

Timing belt tensioner

febi no. 21764

**Seat Cordoba,
Seat Ibiza II, III (1.4 16V AFH, 1.0 16V AVZ)
VW Polo 3 (1.4 16V AFH)**

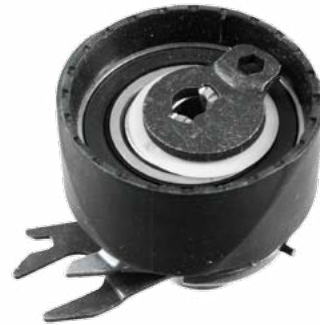
Repl. No. 036 109 243 J

febi recommends using timing belt tensioner febi 21764 (repl. no. 036 109 243 J). This noise-optimised belt tensioner has been developed specially for the applications outlined above. The running surface of the belt tensioner has diagonal elevations (see photos). It is deliberately like this to ensure that the timing belt runs more smoothly. The uneven running surface reduces vibration of the timing belt. At the same time, it also means a longer service life for the timing belt.

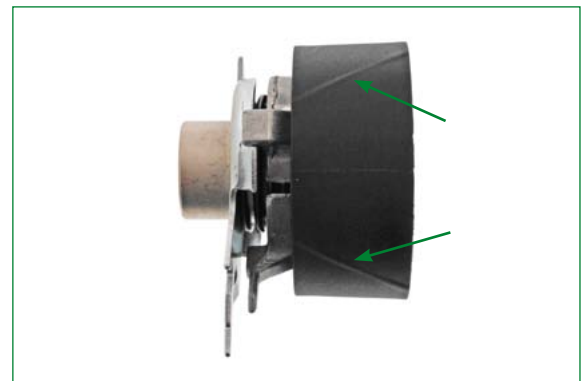
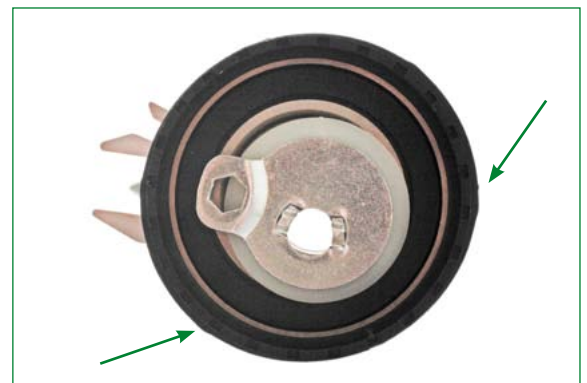
The running surface of the tension roller with diagonal elevations is not a production fault! The tightening torque of the tension roller screw is 20 Nm.
