# Technical Bulletin

## Tensioning issues on Chevrolet/Daewoo 16V petrol engines

5419XS/K015419XS

Chevrolet/Daewoo

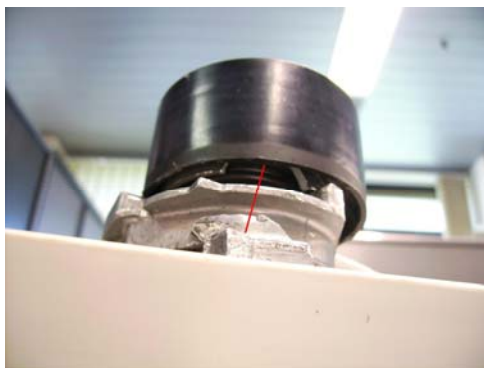
Fig. 2

the new belt, the pointer of the tensioner has to be pushed back. When trying this with a screwdriver, one risks that the screwdriver will slip off the pointer (because of the high spring tension) which will again hit the cold stop.

This can break off the tensioner pointer (Fig 2).

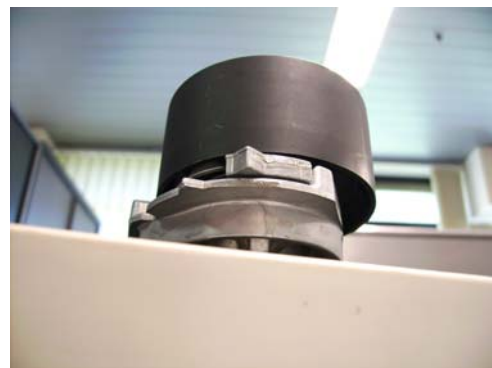
Fig. 3 shows where the pointer is situated on a good tensioner (in its rest position).

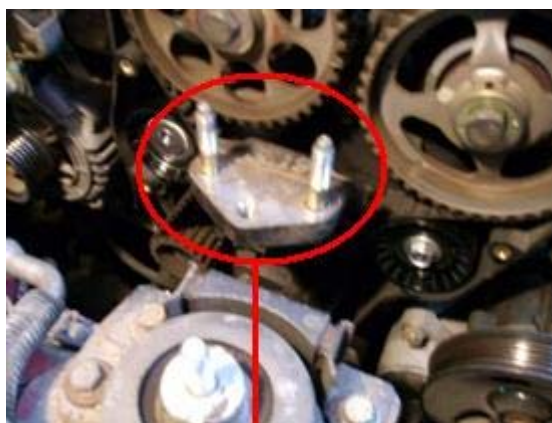
Fig. 4

In order to make access to the drive easier, it is recommended to remove the engine support (Fig. 4)

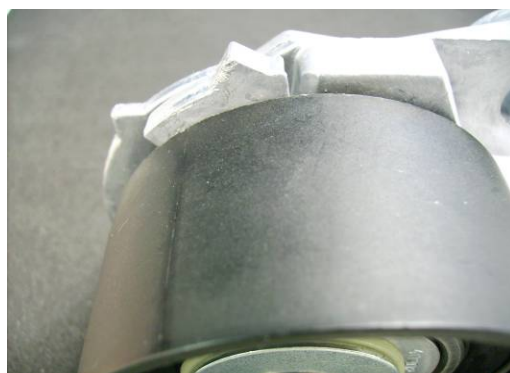
1. Install a new tensioner and idler, and fit the new belt (anticlockwise, starting from crankshaft). Use kit K015419XS.
2. adjust tensioner pointer up to the notch in the tensioner back plate - close to the right hand stop - by rotating the water pump gently clockwise (Fig. 6, 7 and 8).

Fig. 6 View from front

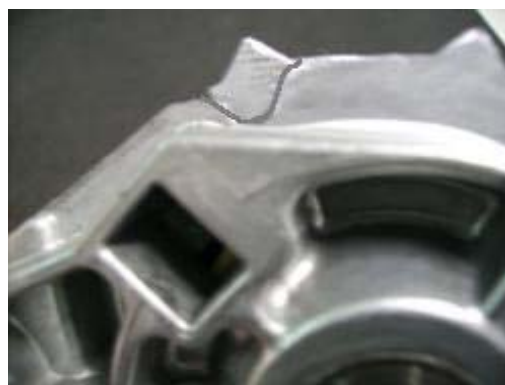
Fig. 7 View from back

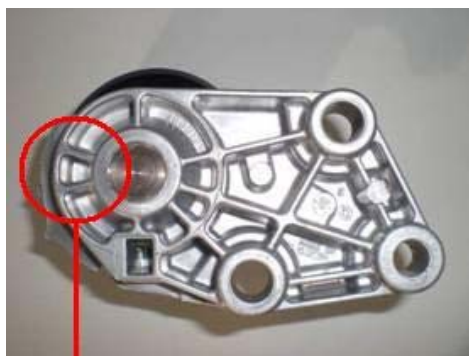
Fig. 10

In addition, one has to watch out for counterfeit tensioners which can be widespread in certain markets (Fig.10 and 11 are OE, Fig. 12 is counterfeit)

OE

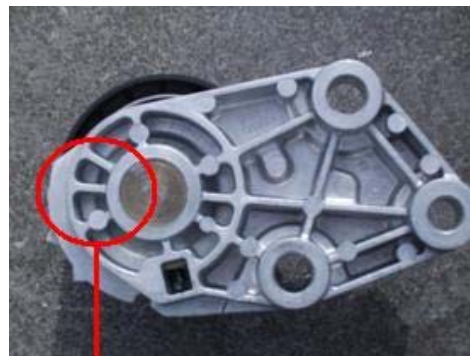
Fig. 11

OE

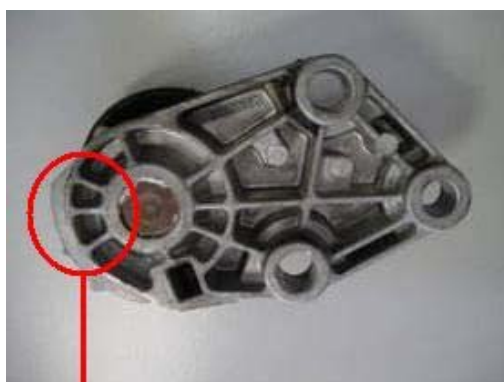
Fig. 12

Counterfeit
