Issue no. 3/2014:

Oil filter OX 171/2D: engine damage caused by dangerous replicas

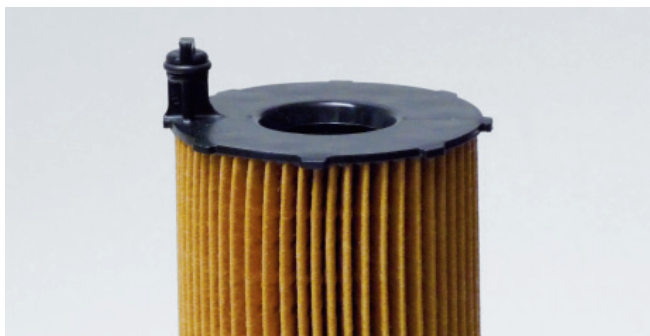
Figure 1: Well thought-out to the last detail: the patented pin for the MAHLE oil filter insert with O-ring seal.

A black plastic mandrel with an O-ring seal is mounted at the end plate of the filter element—known throughout the industry as the MAHLE pin. In the assembled state, the pin fits precisely into the bore in the filter housing and seals it off.

The new MAHLE filter is also equipped with a pin and a seal. As a result, the return bore is completely closed again during assembly and during operation, all the engine oil is fed and cleaned through the filter paper—just as it should be.

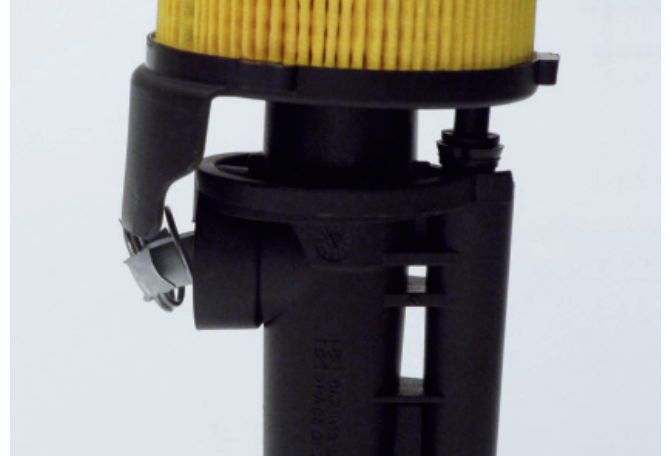
Figure 4: Detailed view of the damaged by-pass valve.

Another problem: the sharp plastic blade can come dangerously close to the by-pass valve in the housing, damage it, and put it out of action. This means: the by-pass valve, which should only be opened for short periods in certain situations, is now permanently open—and lets the unfiltered oil circulate (unnoticed!) continuously through the engine. The inevitable consequence is serious engine damage!
