SI 1856
For technical personnel only!
1/2

SERVICE INFORMATION

WATER PUMPS FROM AUDI/SEAT/ŠKODA/VW

DANGER OF BREAKAGE: NOTE DURING FITTING!

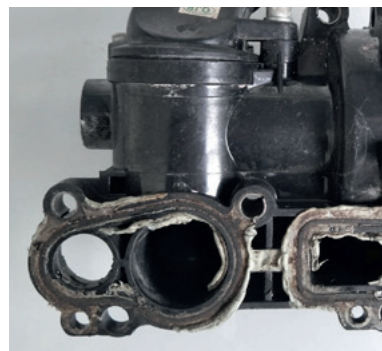
Fig. 5: Leakage due to additional sealant (damage symptoms)

- All gaskets of this water pump are exclusively designed for use with cooling liquid. They must never be oiled, e.g. with engine oil.
- The area around the installation location and the coolant agent must also be free from impurities.
- Contact with oil could cause the gaskets to swell in their groove, and the housing of the pump may break.
- Do not use additional sealant. The pump may develop leaks (Fig. 5).
